## GALLERY CORING HINZE DAM STAGE 3

### OVERVIEW OF PROJECT

### DRAINAGE GALLERY BREIF

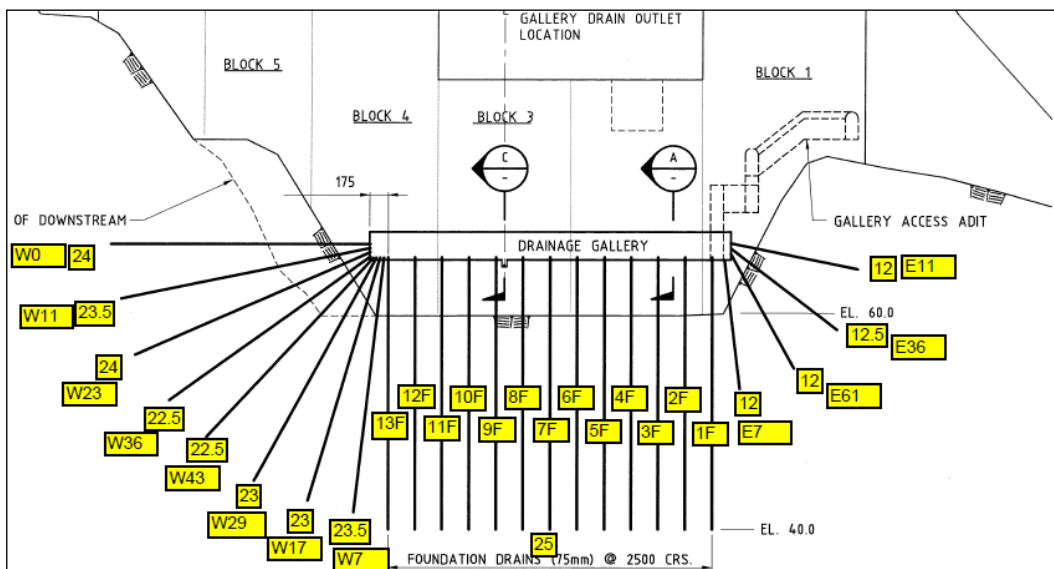
Figure 1 – Drainage Gallery Elevation showing Hole Depths and Numbering System

The Stage 3 upgrade shared a modified version of the Stage 2 gallery. To ensure that increased hydrostatic pressures generated by the elevated height of the wall were controlled a number of pressure relief holes measuring up to 25meters deep were cored in various areas of the gallery floor and walls, see figure 1 for core hole layout

The existing drainage gallery measured 2.5m high by 1.2m long by 35m wide. It was accessible via several flights of stairs from the upper portion of the spillway, see figure 1.

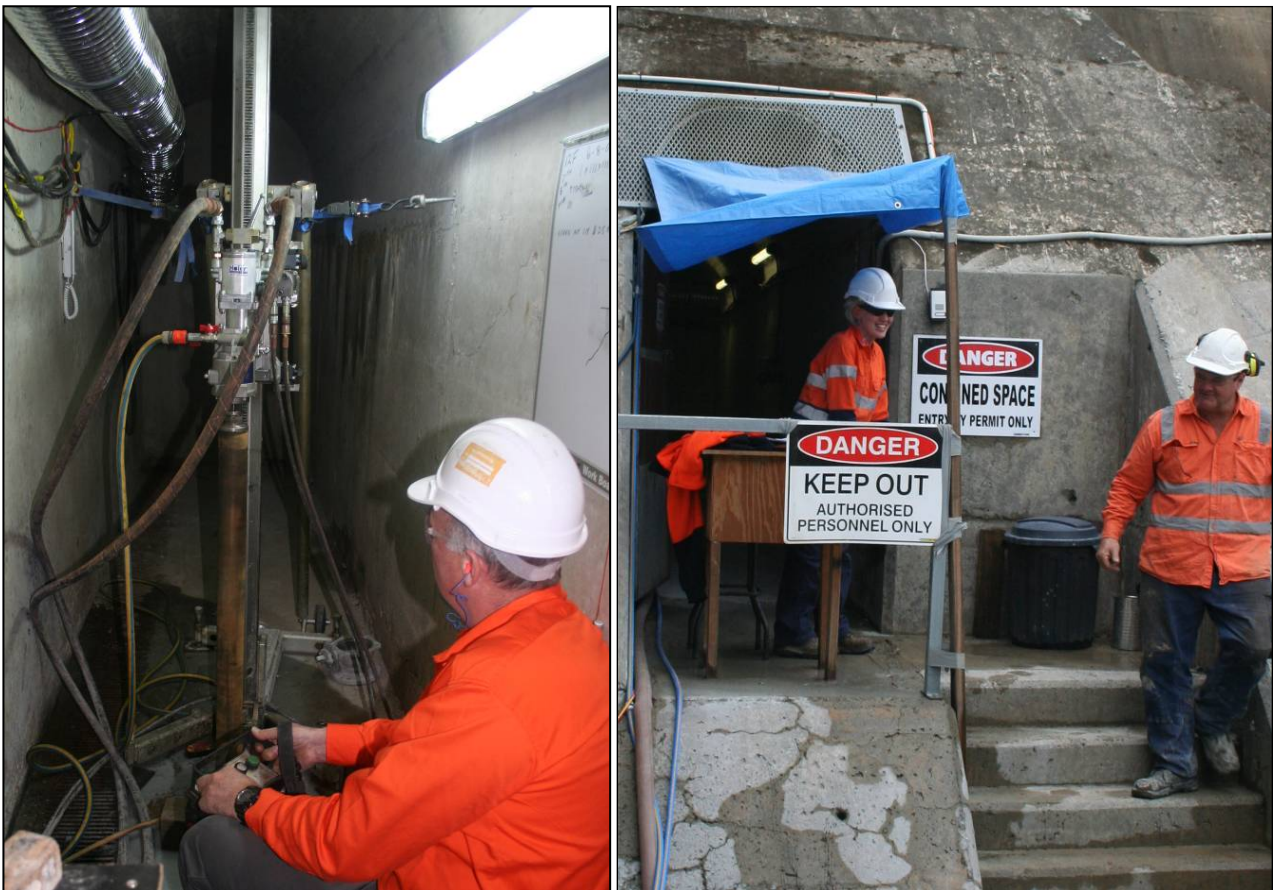
The required drilling apparatus could not generate exhaust fumes within the enclosed area therefore hydraulic drilling equipment was chosen to complete the work. This gear was exhaust free, quiet and provided powerful and efficient cutting conditions.

*Figure 2 – Left: Entrance to the Spillway Drainage Gallery  
Right: Hydraulic Drilling Equipment*

To work in a confined space all DecoTEC operators had to be confined space trained. In addition to this a spotter was also required to stand at the gallery entrance at all times in case of an emergency. Pneumatic powered ventilation fans, a 4four point intercom system and fixed gas monitors were installed to provided the operators with the safest possible working environment.

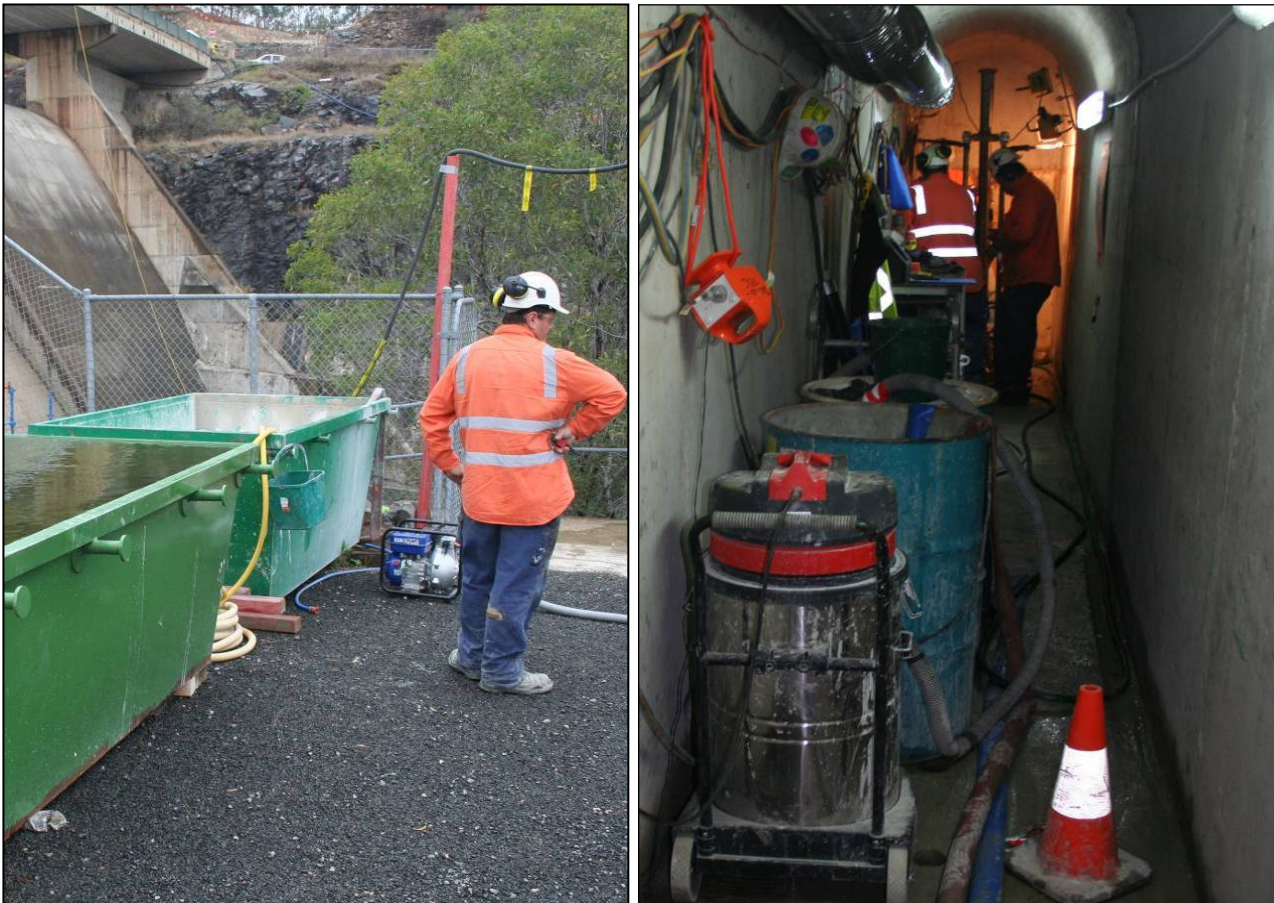
To ensure the works did not negatively impact on the environment all slurry needed to be treated for pH and disposed of into the site sediment basin. To collect and treat the slurry DecoTEC installed an innovative slurry control system. This system consisted of a wet-vac continuously sucking slurry from a collection pit within the gallery. The wet-vac's factory tank was modified to expel the slurry into a 205 litre tank to reduce the need to attend to the slurry system. Once full these tanks were then automatically stage pumped up the multiple flights of stairs into a 3kL bin located adjacent to the gallery entrance. The slurry in this bin was then treated for pH and, with the aid of flocculent, left to settle before disposing of in the sediment basin via an onsite vacuum truck.

Water was provided to core drills via a 3kL tank and a fire pump located outside the gallery.

*Figure 3 – Left: Gallery Floor Slurry Control System  
Right: Slurry Collection Tank and Water Supply Tank*

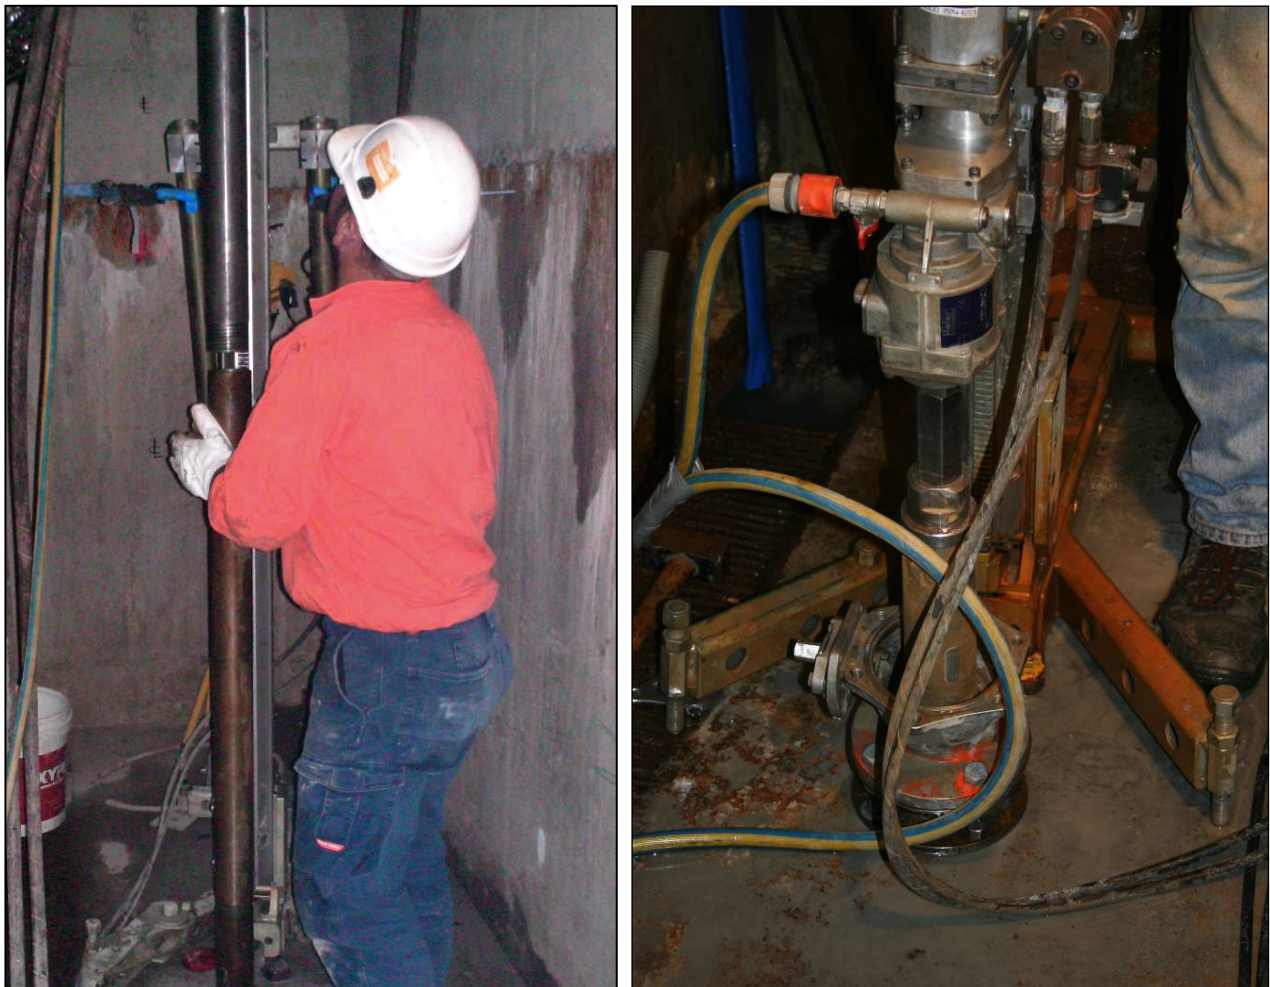
To core to the required angles and depths within an extremely small margin of error diamond core drilling was chosen to carry out the works. To stay within the clients' program two drill rigs with specially fabricated diamond core cutting heads were used. These cutter heads provided a precision cut to the desired diameter whilst maintaining the required production rates.

Due to the tight fit inside the gallery 1metre screw type core barrels were used. Every metre of cutting required a new barrel to be screwed onto the chain. To ensure the holes would stay on line with how they were initially setup reamers were used. Several of these were installed throughout the chain of barrels and provided the barrels with a tight fit inside the hole.

At the time of coring there was up to 15 meters of head in the dam. This therefore created the potential for water to backflow out of the cored holes generating a safety hazard. Even though the calculated maximum backflow pressure was only minimal DecoTEC wanted to ensure the uttermost safety for their operators therefore a backflow valve was fabricated and installed on each hole.

*Figure 4 – Drilling Equipment*

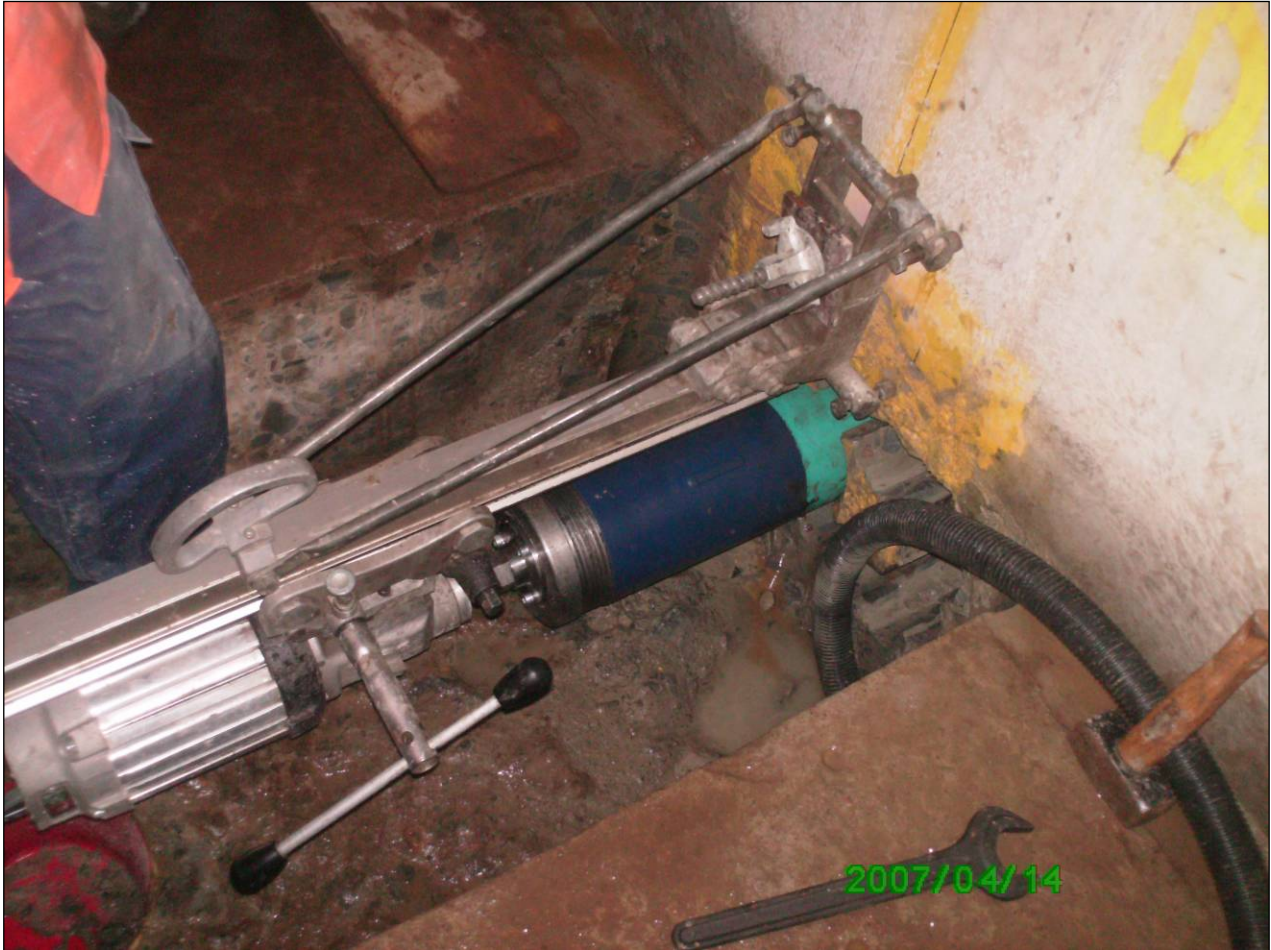
The horizontal outbound drain hole measured 160mm in diameter and was located below the floor of the gallery. This required a cavity in the gallery floor and a recess in the downstream gallery wall to be cut out to make room for the drilling gear. Along with this tight fit DecoTEC also had to ensure that the appropriate fall was maintained along the entire 18metre length of the hole.

*Figure 5 – 160mm Diameter Drain Hole*
