HINZE DAM STAGE 3 PROJECT

Spillway Bridge Deconstruction

STAGE 2 SPILLWAY BRIDGE

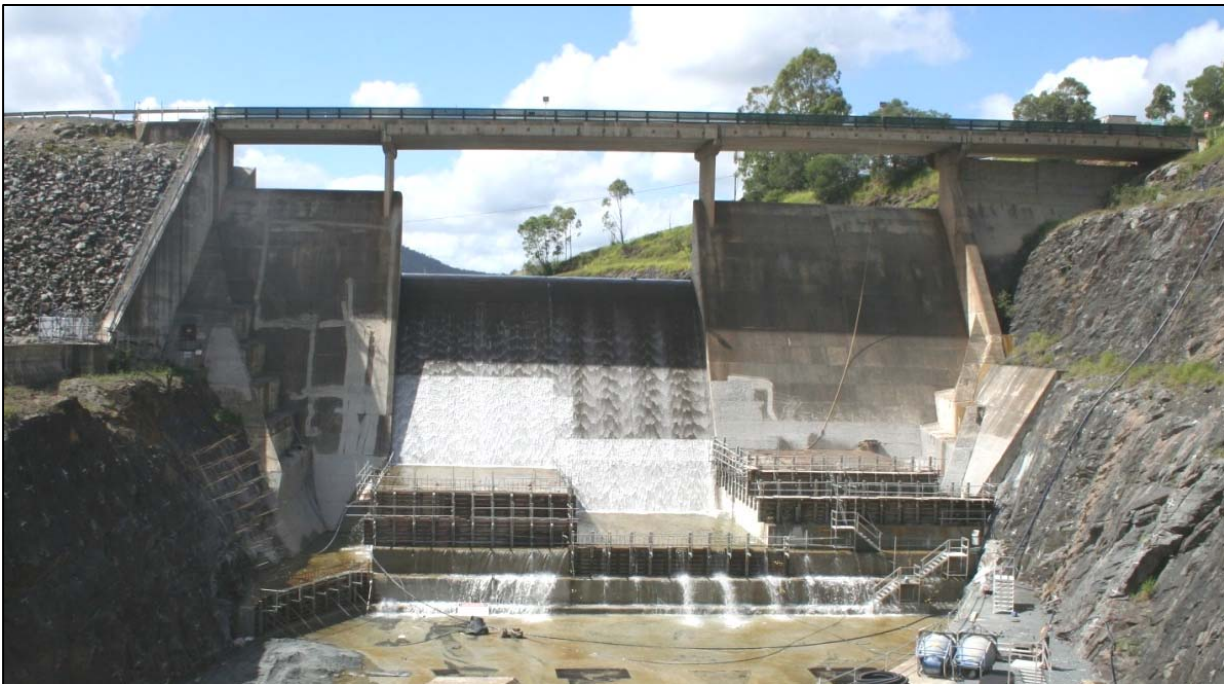
Figure 1 – Stage 2 Spillway Bridge to be Removed

The existing stage 2 spillway bridge consists of 4 spans totalling 85m long. Each span is made up of 15 prestressed beams totalling 9m wide. The largest of these spans (span 3) contains beams weighing 32tonnes each. The bridge is situated over the Hinze Dam Spillway and serves as the local traffic access across the dam.

The stage 3 upgrade scope includes raising the spillway and embankment by 15 metres therefore requiring the existing bridge to be removed to make way for construction of the new spillway and bridge.

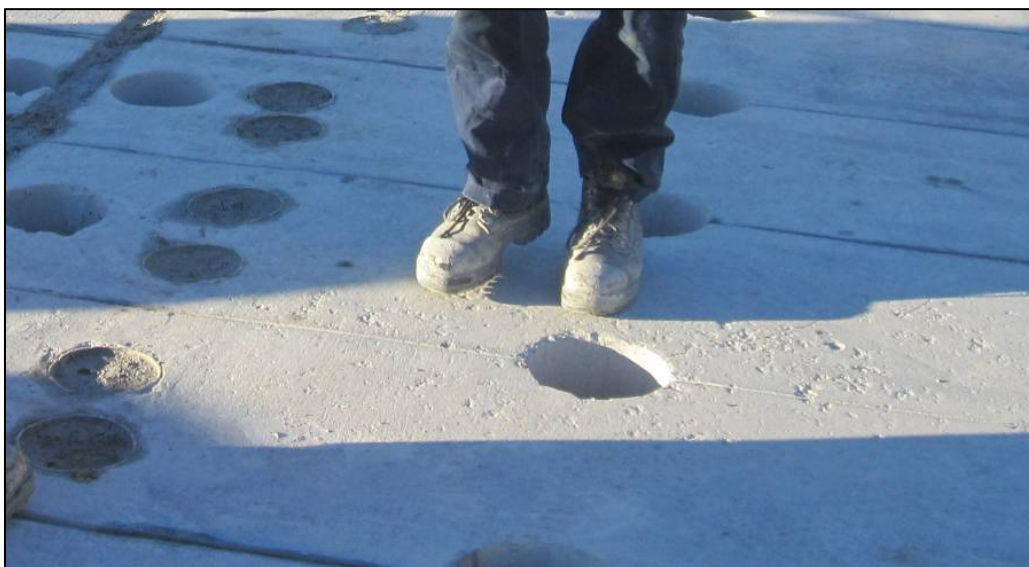
Figure 3 – Sawing and Coring Preparing Bridge for Separation

Each span of 15 beams were tied together by means of a topping slab doweled into the beam joins. 2 Steps were required to ensure total separation of the beams prior to lifting

- Floor saw cut to depth of topping slab (250mm) over each beam joint
- Core drill 2 by 200mm & 48mm diameter holes at this joint for hydraulic splitter access, explained further in step three.

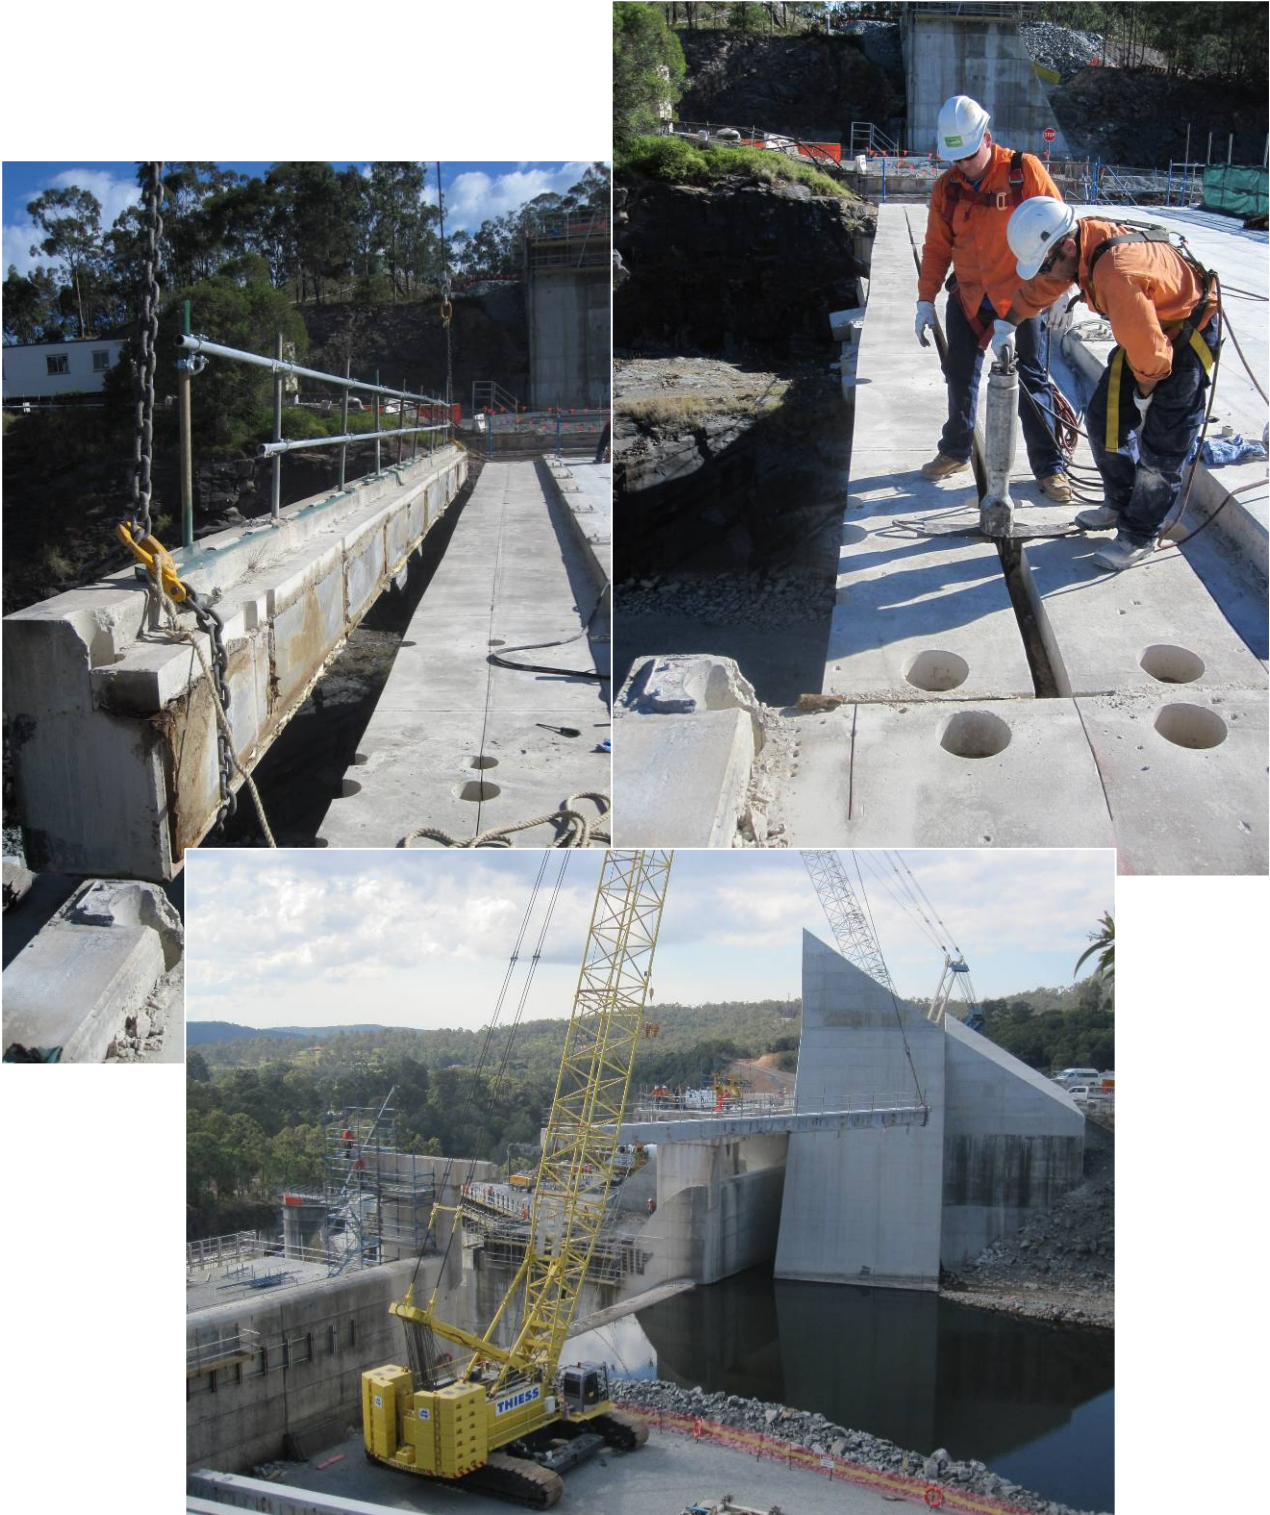
Figure 4 – Splitting and Removing Bridge Beams

Each beam was then required to be hydraulically pushed 100mm from the adjacent beam to ensure total separation was achieved whilst providing space for rigging gear. All DecoTEC operators and riggers were required to be trained in 'working at heights' due to access restrictions.
