HINZE DAM STAGE 3 PROJECT Stage 1 Ogee Slot

Project Hinze Dam Stage 3 Work Item: Stage 1 Ogee Demolition

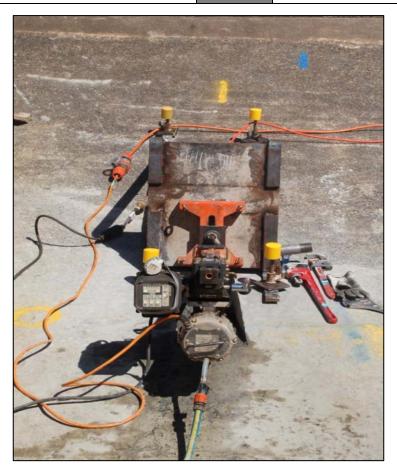
Set-up to drill 50mm wire holes 14.5 metres through lower ogee using 3 phase lower automated drill rig.

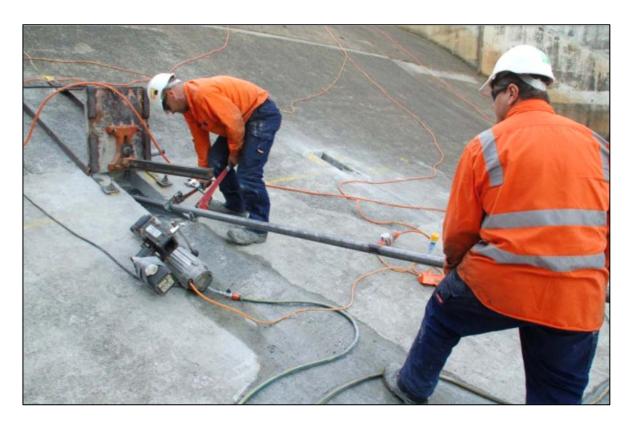
Each of the wire feed holes were drilled using continious barrells. An accuracy of +/- 50mm was maintained in all drilled holes.

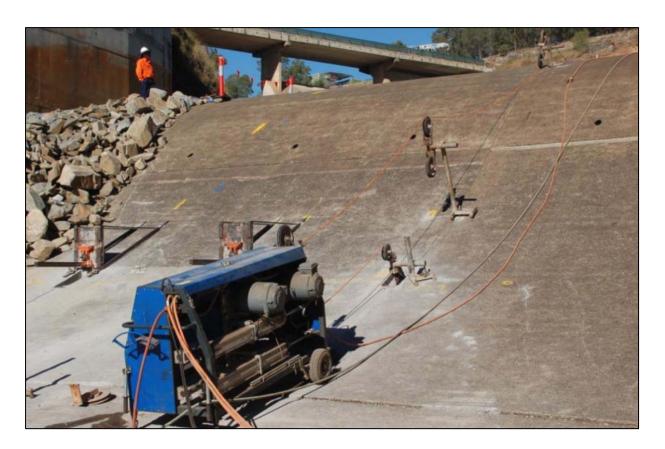
Wire saw was set-up and wire fed through the cored hole and back over top off ogee.

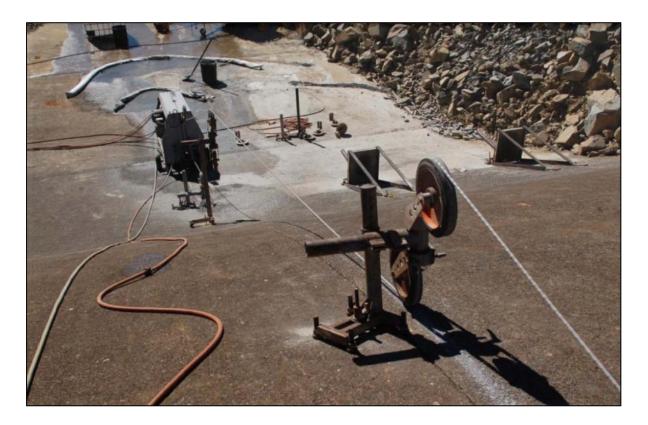
Tension is taken up and cutting begins all excess wire is taken up within the wire saw storage unit as the wire is continuously pulled through the concrete.

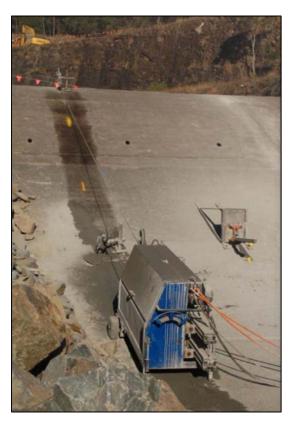
Set-up on left cut

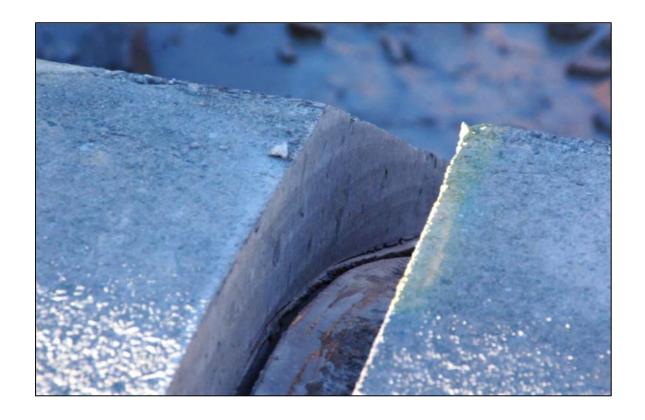
Section through right cut showing control joint and water stop.

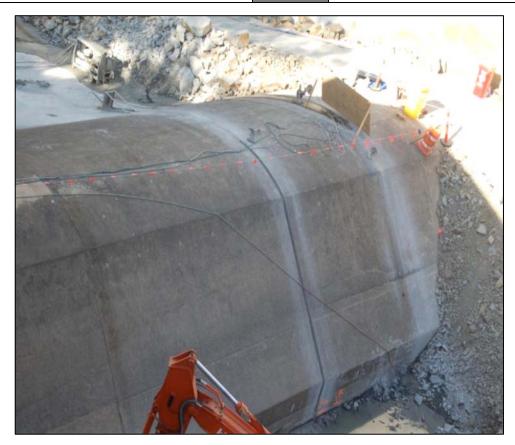
Left and right cuts after completion giving full separation from the surrounding concrete. The concrete contained 20 and 30mm reo bars at 200mm centres.

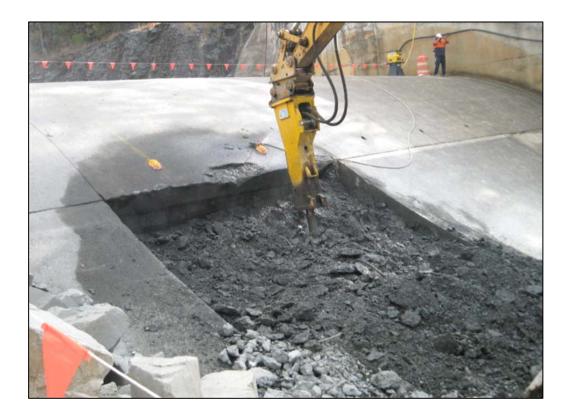
Concrete was then removed with a 20 tonne excavator.

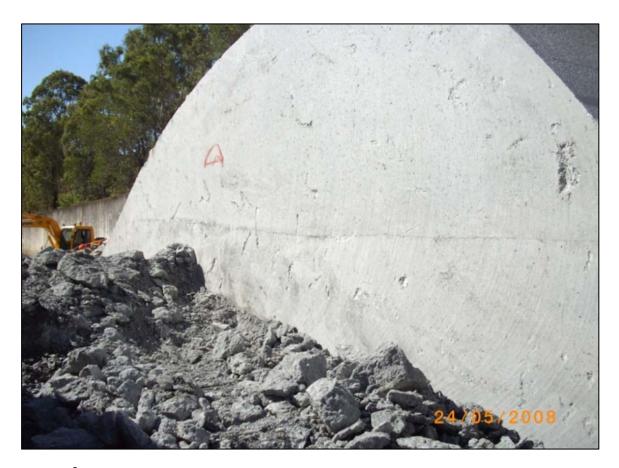
In all 240m^3 of concrete was removed each cut face was 14.5m long x 5m high approx. Allowing for the ogee shape a total of 48m^2 was cut on each face.

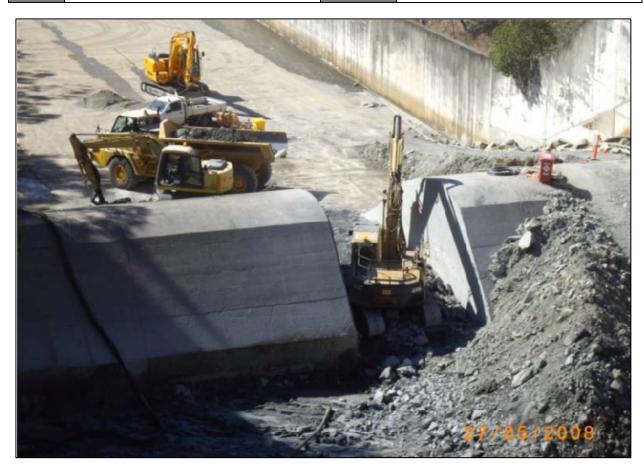
The final opening was large enough to drive a Moxy truck through and would provide access to the upper spillway mass concrete pouring
