STRUCTURAL MODIFICATION

WIRE SAW, BURST & LIFT

REF No. D/A13

Project: Wellington Dam Upgrade

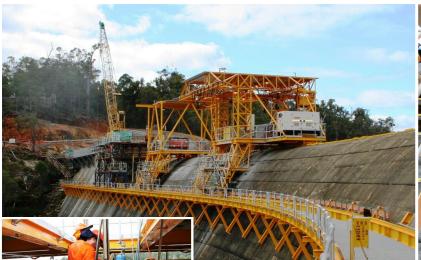
Part of DecoTEC's contract involved creating 28 slots in the overflow crest to allow for the installation of bridge piers.

The approach: Assist in the design and implementation of four cutting and drilling trolleys which were assembled onsite and lifted into position on top of the overflow crest. The first trolley on each side of the dam went ahead to wire saw the slots, burst the freed section into blocks, lift the blocks from the crest and lower them

into the dam via an engineered remote release rig. A second trolley followed the first on each end of the spillway which concentrated on drilling, inProgram were easily succeeded. To achieve highly successful results like these DecoTEC encompass an experienced management team with a strong
