REF No. D/A12

Location: Project: WELLINGTON DAM ALLIANCE Wellington Dam, Collie WA, Australia Wellington Dam Upgrade

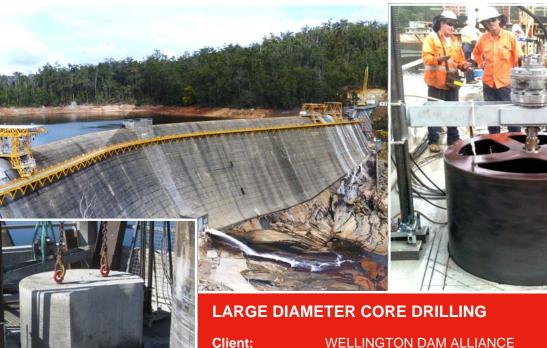
were diamond core drilled to overlap each other. The base of these cores was then broken with a hydraulic ram called a burster. and Technical Design team along with its experienced Operators guaranteed the success of this project. The client expressed satisfaction

Due to the nature of the works the existing concrete reinforcement could not be located which introduced a threat that would impede the cores from being lifted out of the abutment. DecoTEC engineered a hydraulic jacking system which was certified to lift 3 times the weight of the core. This additional force was then able to free the core from any steel reinforcement which was encountered.

Once the concrete cores were lifted from the penetration DecoTEC installed confined space controls to allow technicians to enter the cavity and finish shaping the anchor recess as per the design drawings. DecoTEC's creative Engineering with the accuracy of the finished surfaces and the performance of the crew to bring DecoTEC's element of the project in on schedule.
